CLINICAL IMAGE IN GASTROENTEROLOGY

Benign esophageal perforation resolved through the placement of a fully covered self-expandable metal stent[☆]

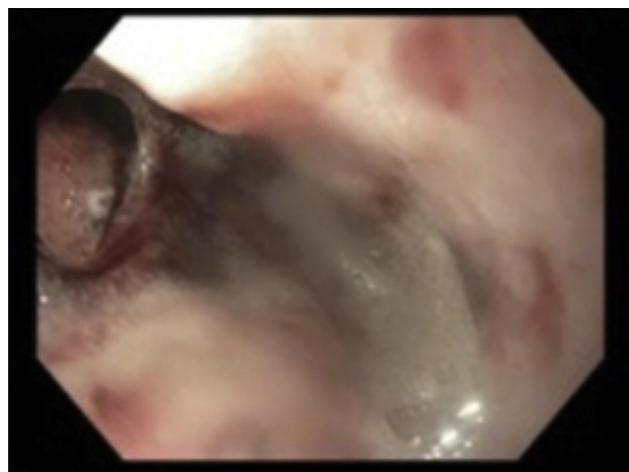
Figure 1 Esophageal perforation.

A 46-year-old woman presented with a history of 30-day nonsteroidal anti-inflammatory drug (NSAID) intake and dysphagia of 8-day progression. Her endoscopic study found a long (12 cm) concentric stricture 22 cm from the dentary arcade for which a gradual dilatation up to 15 mm was performed with Savary-Gilliard dilators; the middle third of the esophagus was perforated during the second dilatation session and the lesion measured approximately 10 mm in diameter (fig. 1). A chest computed tomography scan revealed pneumomediastinum and an image consistent with a perforation located at the middle third of the esophagus on the left lateral surface (fig. 2). Antibiotic therapy was begun

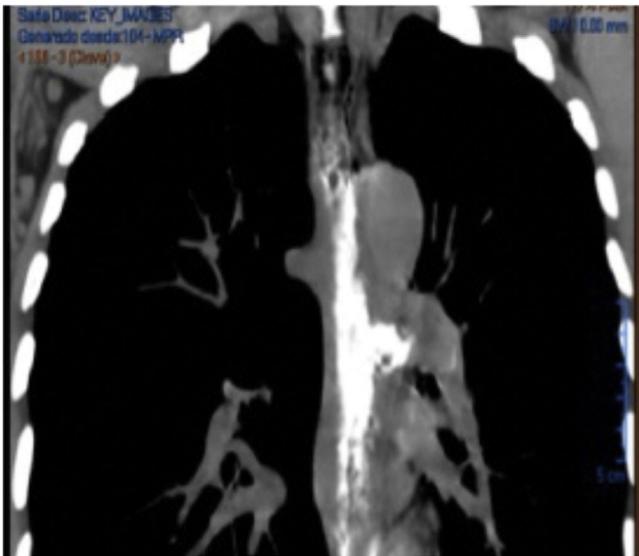
Figure 2 The chest computed tomography scan with contrast medium showing pneumomediastinum and contrast material leakage at the left lateral surface of the esophagus.

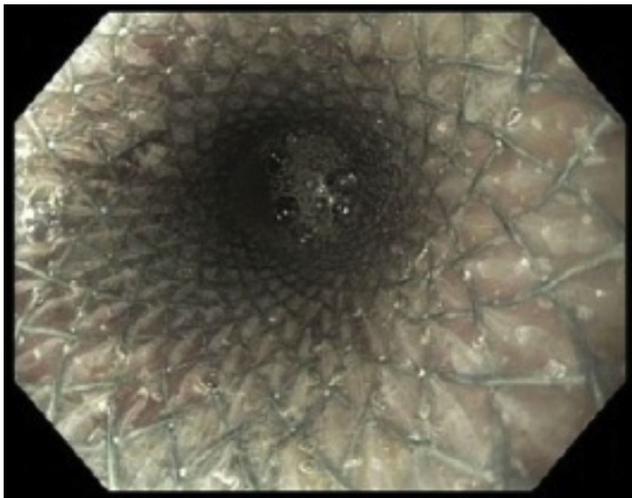
Figure 3 The fully covered esophageal metal stent occluding the entire perforation.

and a 20 x 150 mm fully covered self-expandable metal stent (Niti-S Esophageal Covered Stent, TaeWoong Medical, Seoul, Korea) was placed (fig. 3). A water-soluble contrast swallow (CS) was conducted and it showed adequate passage of

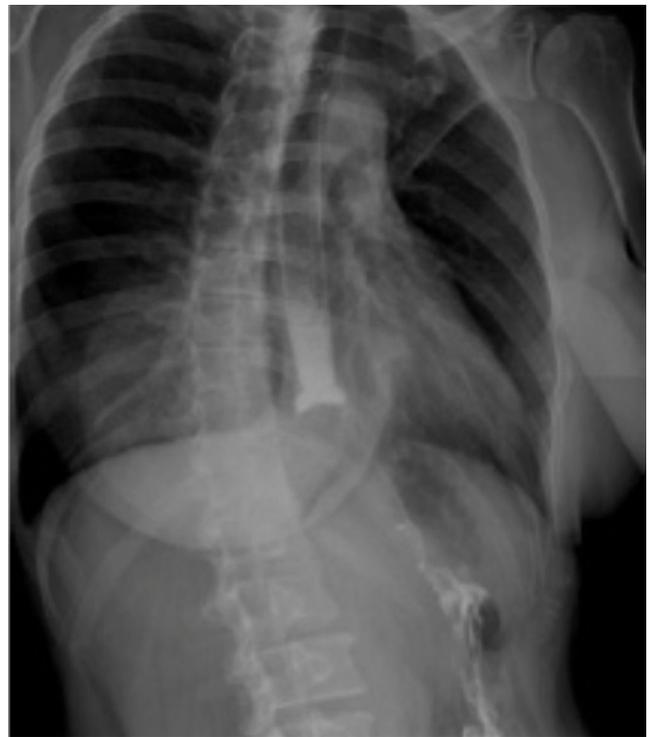
Figure 4 The water-soluble contrast swallow (CS) study in which no leak into the mediastinum is observed.

the contrast medium through the stent with no evidence of leakage (fig. 4). Oral intake was restarted on the fifth day, the stent was removed 28 days later, and no solution of continuity was found in the esophagus.
